## Rural Municipality of East St. Paul Bottomley Creek Bank Remediation and Permanent Dike Construction Update - March 26th to March 31th, 2017

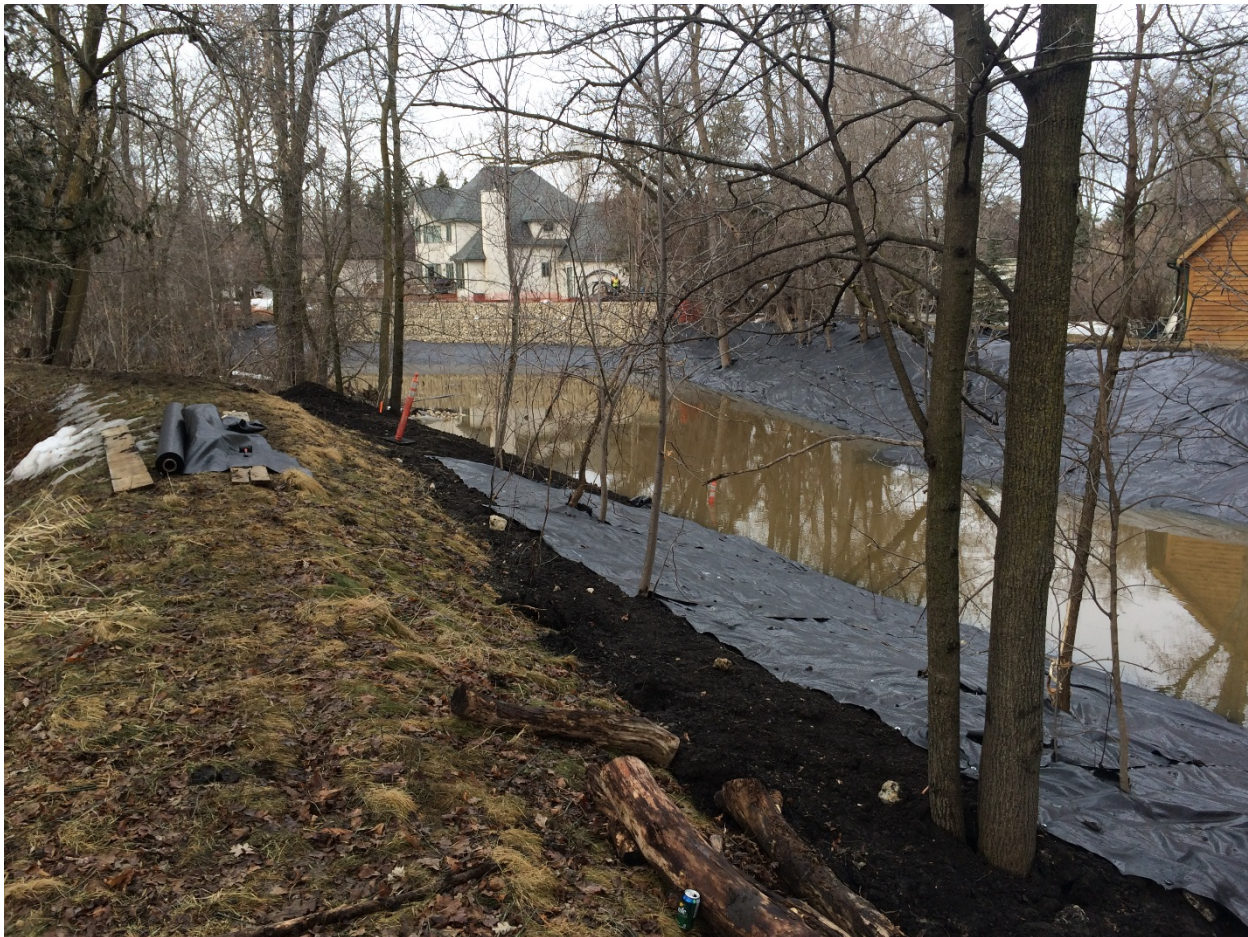
Photo 1 - Topsoil placed with geotextile being placed on top at 3154 Henderson Highway.

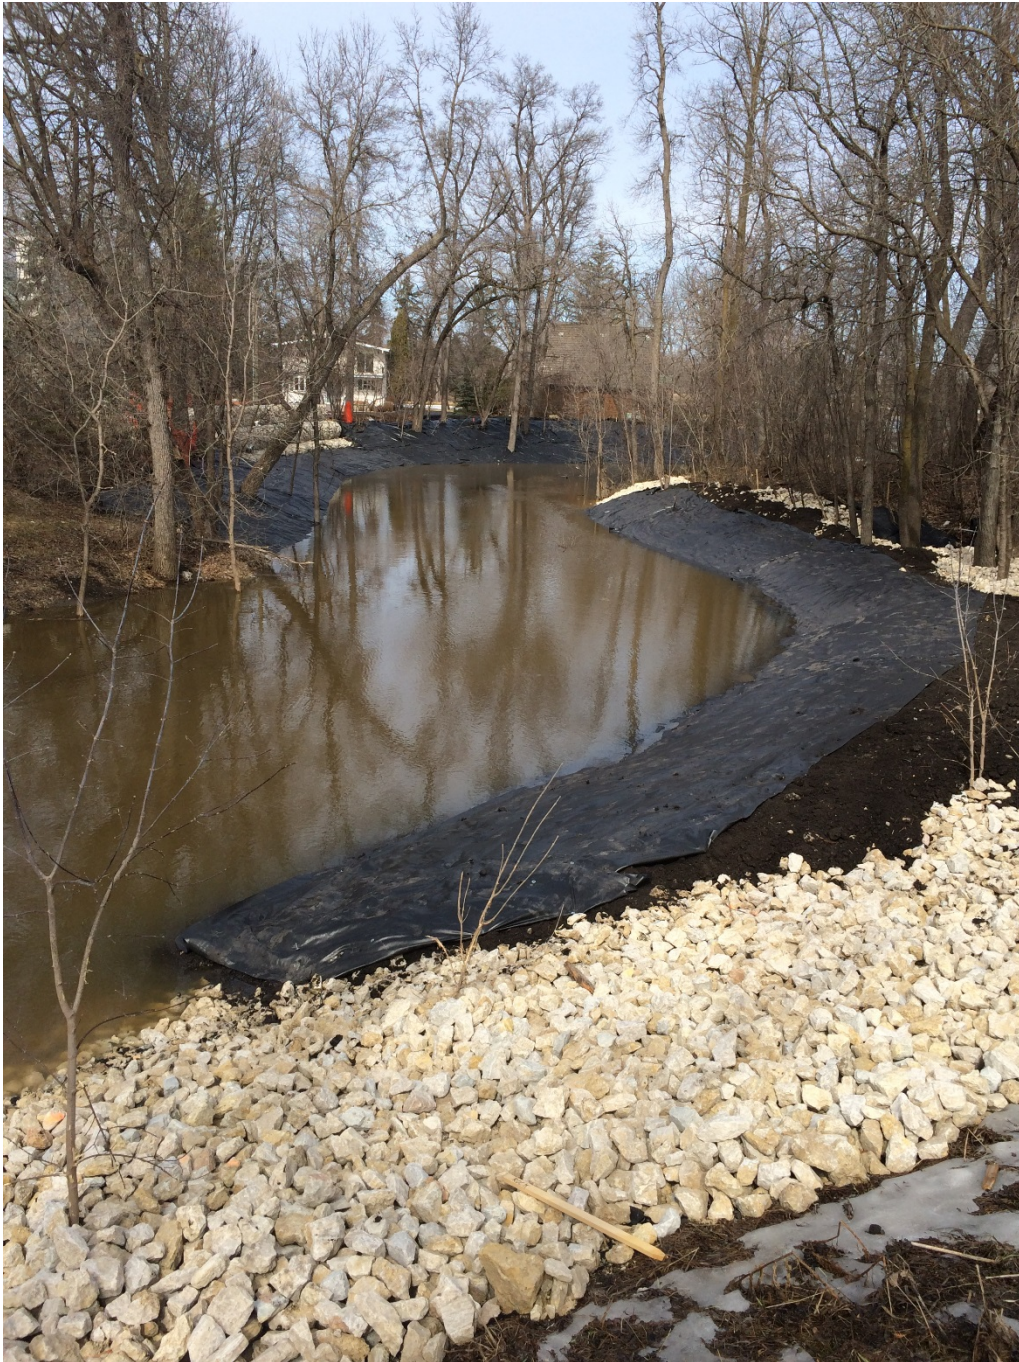
**Photo 2 - Topsoil placed with geotextile on top at 3144 Henderson Highway.**

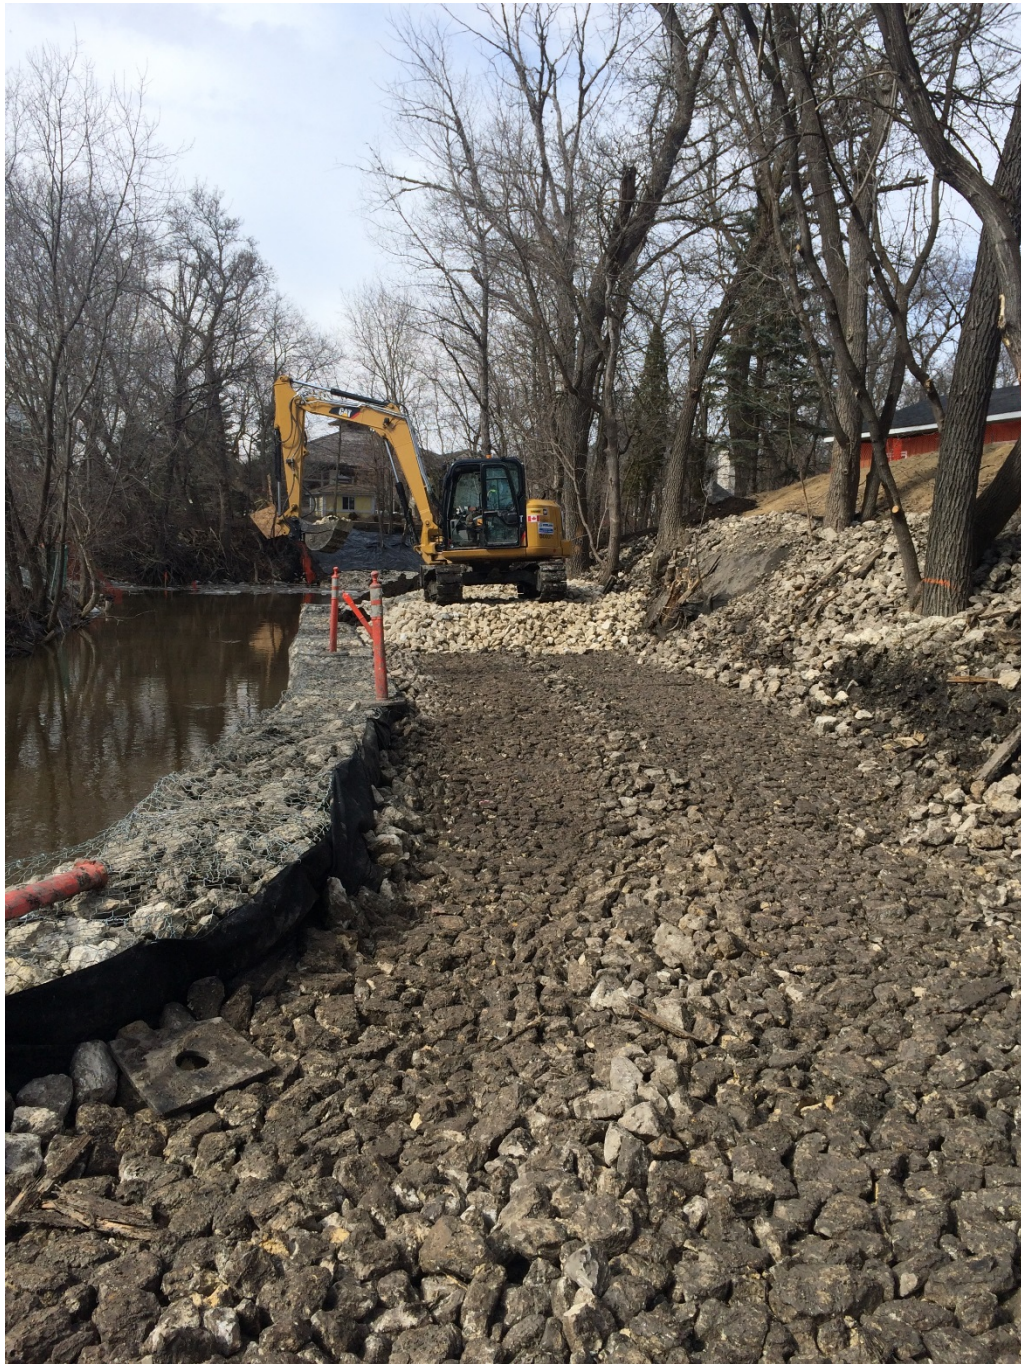
**Photo 3 - Placing rockfill toe berm at 3144 Henderson Highway.**

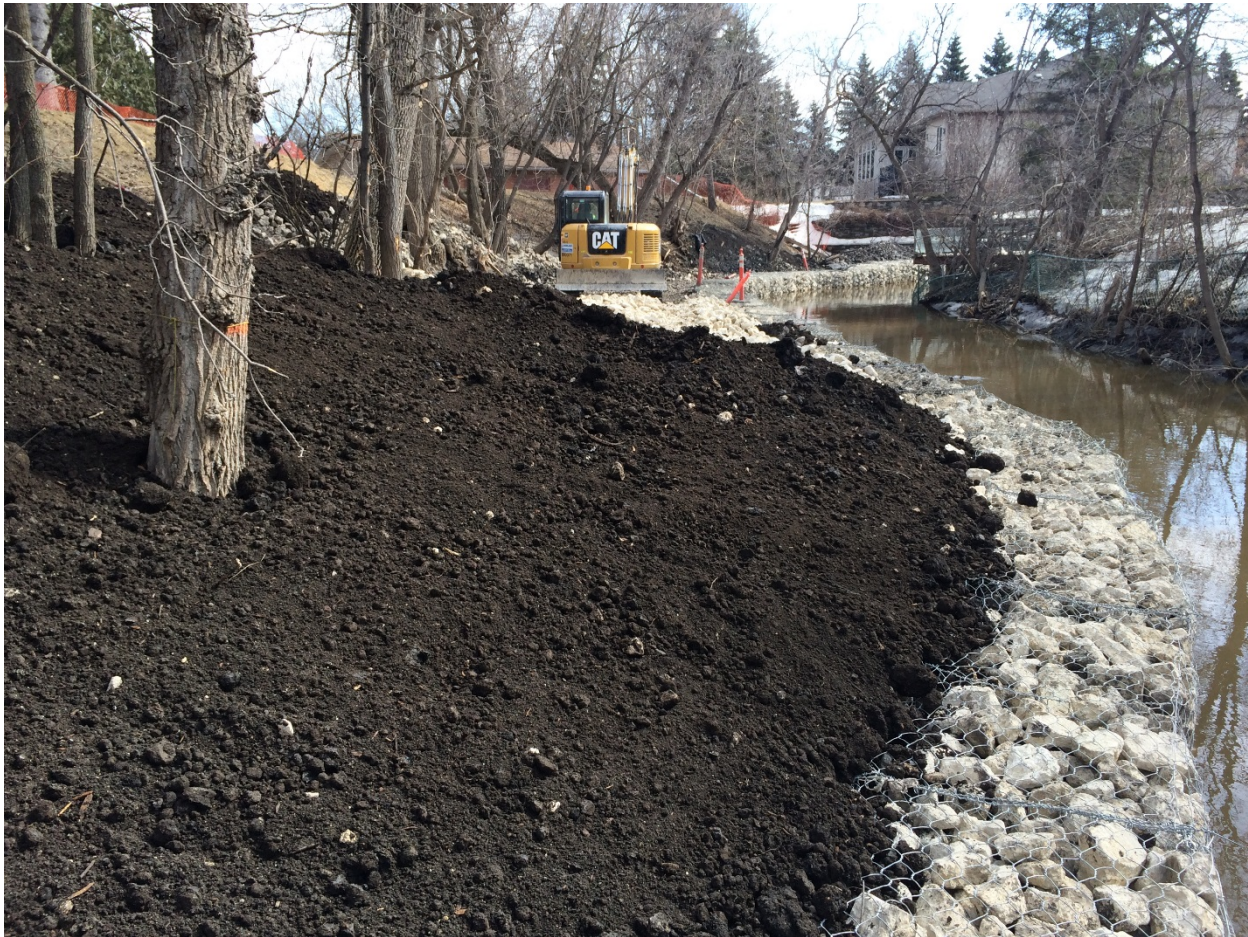
**Photo 4 - Placing topsoil on rockfill toe berm at 3144 Henderson Highway.**

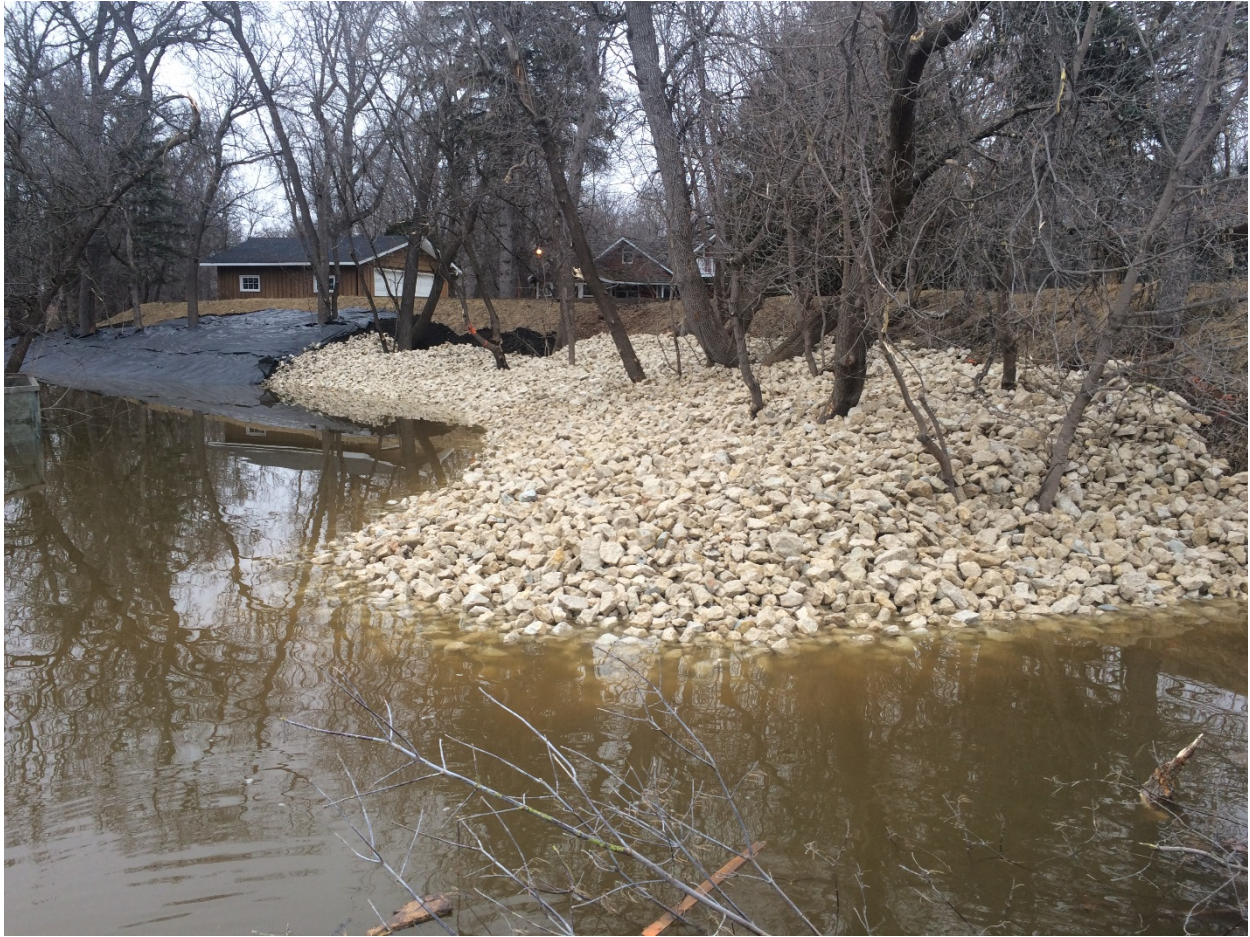
**Photo 5 - Completed rockfill toe berm at 3144 Henderson Highway. Additional topsoil to be placed during Phase 2 of the project.**
